# **The Road Inventory of Ridgefield National Wildlife Refuge Ridgefield, WA**

Prepared By:  
Federal Highway Administration  
Central Federal Lands Highway Division  
February 2013

## Ridgefield - 13551

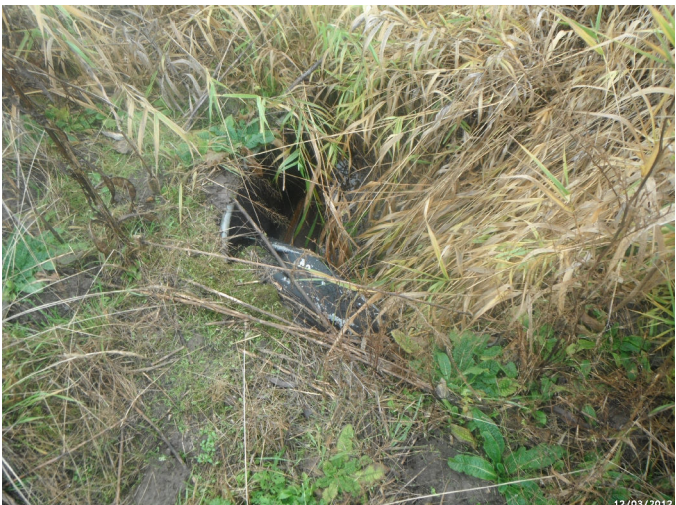
Photo: RIDG\_C4\_4336 Route: 405-001-0.41  
Metal WCS Flashboard Riser 40ft long 24in dia. 2ft deep

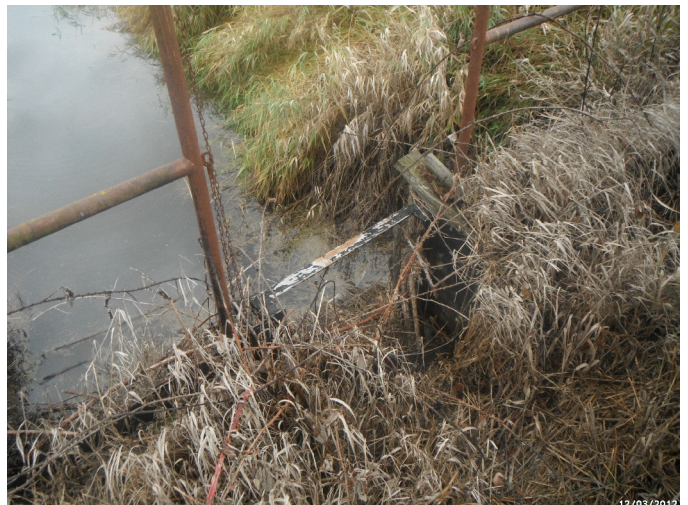
Photo: RIDG\_C4\_4337 Route: 405-001-0.51  
Metal WCS  
Flashboard Riser 40ft long 24in dia. 2ft deep

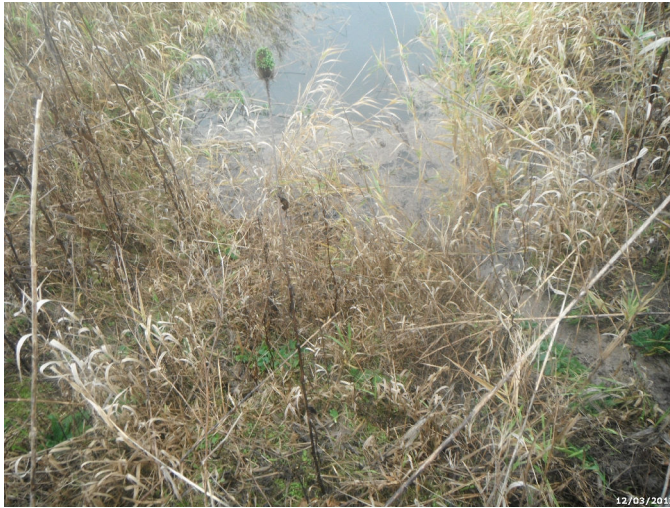
Photo: RIDG\_C4\_4338 Route: 405-001-0.51

Metal WCS Flashboard Riser 40ft long 24in dia. 2ft deep

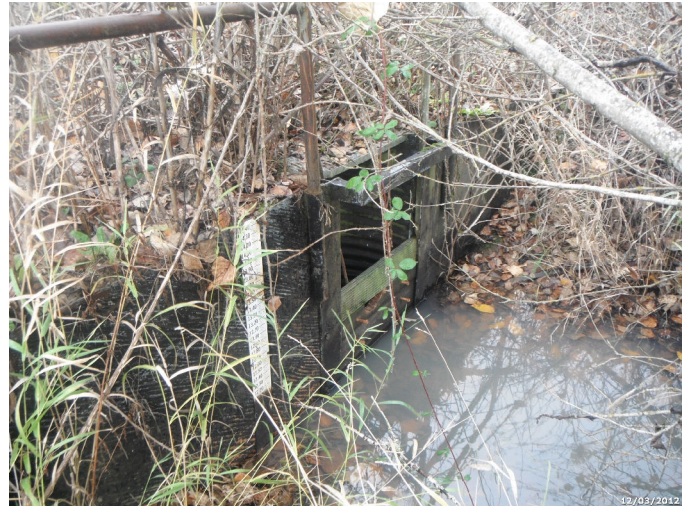
Photo: RIDG\_C4\_4347 Route: 408-001-0.07  
Metal WCS Flashboard Riser 30ft long 24in dia. 3ft deep

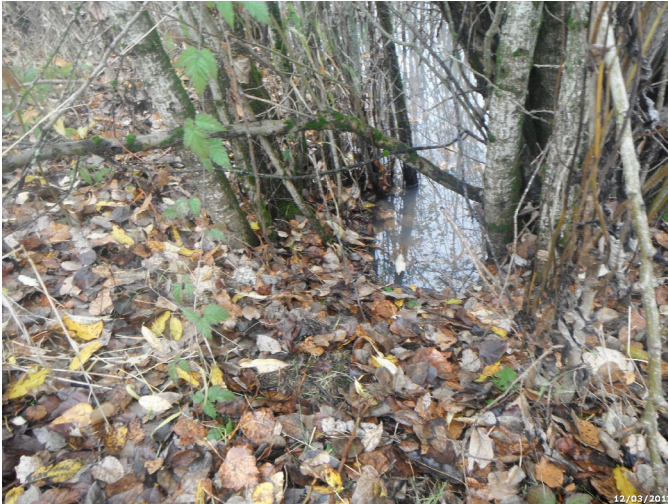
Photo: RIDG\_C4\_4348 Route: 408-001-0.07  
Metal WCS Flashboard Riser 30ft long 24in dia. 3ft deep

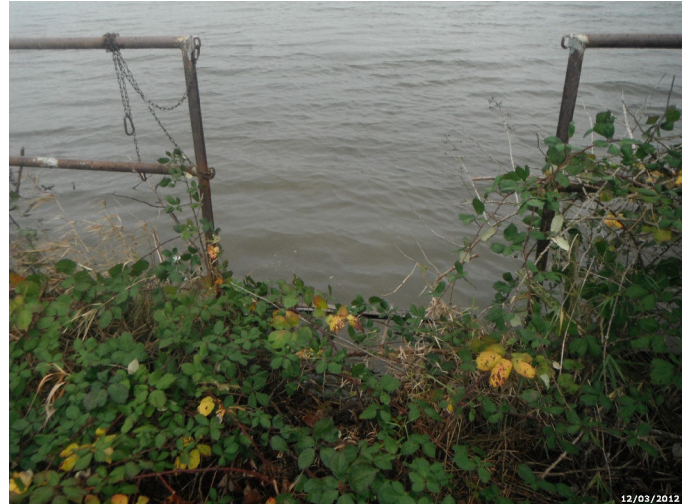
Photo: RIDG\_C4\_4349 Route: 408-001-0.19  
Metal WCS Flashboard Riser 30ft long 24in dia. 3ft deep

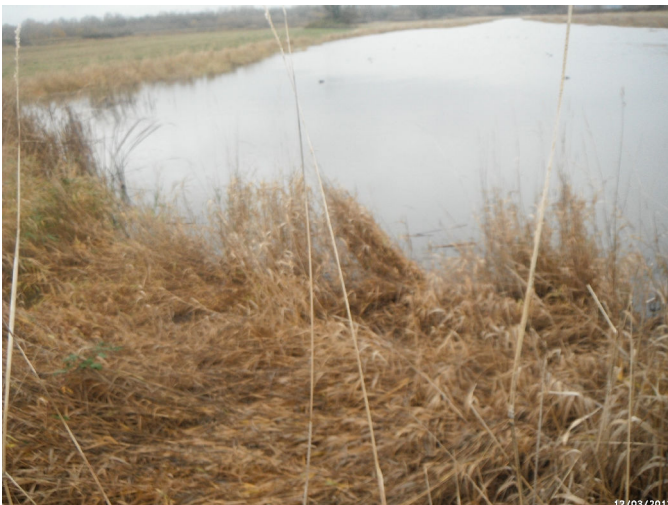
Photo: RIDG\_C4\_4350 Route: 408-001-0.19  
Metal WCS Flashboard Riser 30ft long 24in dia. 3ft deep

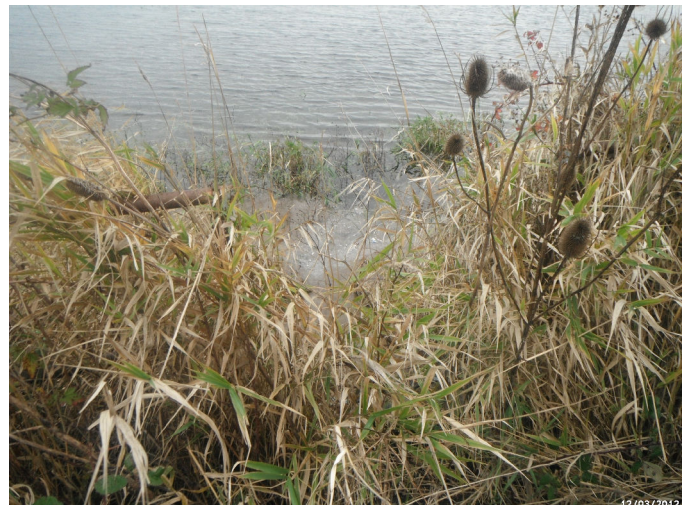
Photo: RIDG\_C4\_4351 Route: 408-001-0.3  
Metal WCS Flashboard Riser 25ft long 24in dia. 2ft deep  
8-021

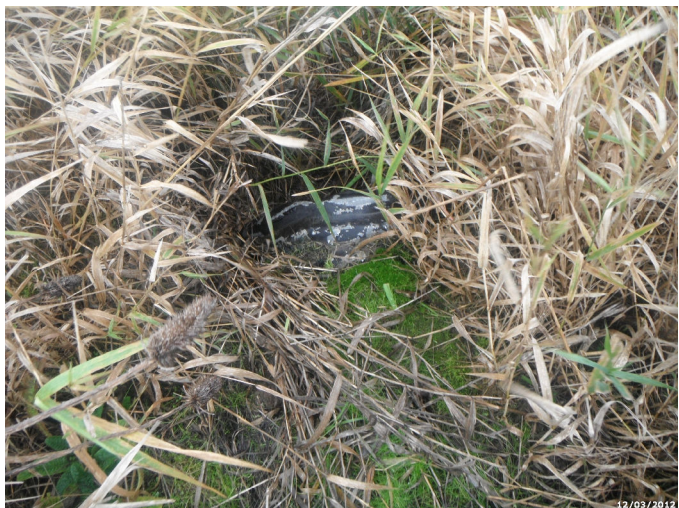
Photo: RIDG\_C4\_4352 Route: 408-001-0.3  
Metal WCS Flashboard Riser 25ft long 24in dia. 2ft deep

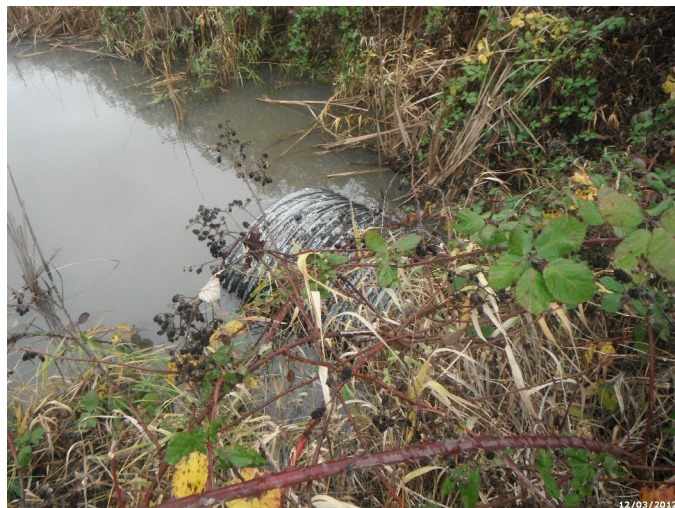
Photo: RIDG\_C4\_4353 Route: 408-001-0.38  
Metal Culvert 60ft long 48in dia. 3ft deep

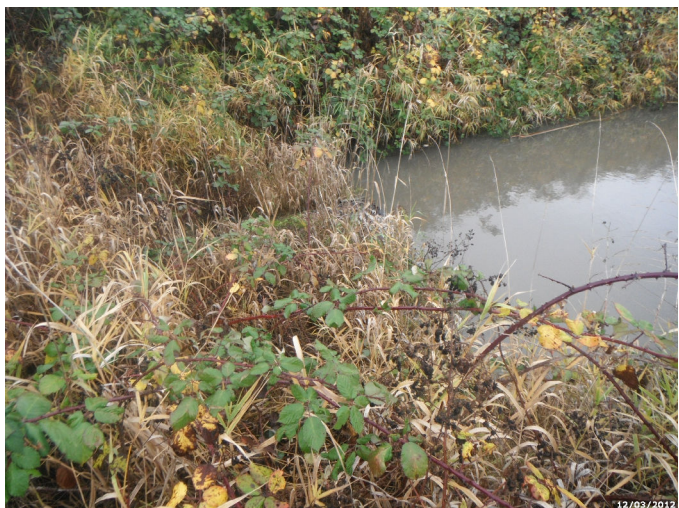
Photo: RIDG\_C4\_4354 Route: 408-001-0.38  
Metal Culvert 60ft long 48in dia. 3ft deep

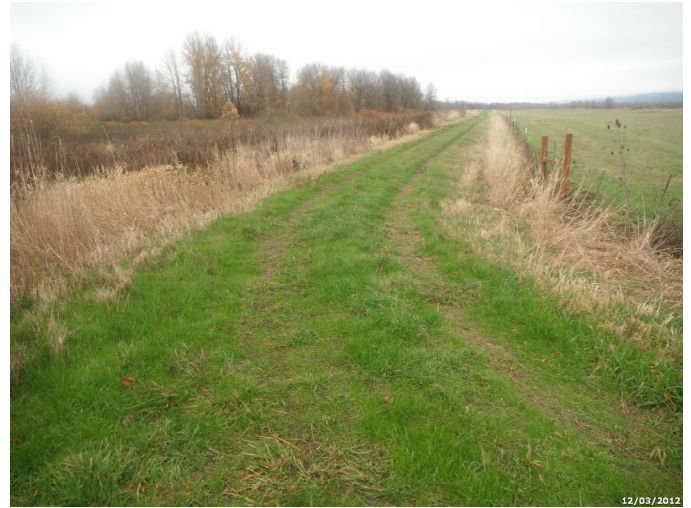
Photo: RIDG\_C4\_4356 Route: 409-001-0.58  
Problem Area Road too wet to continue

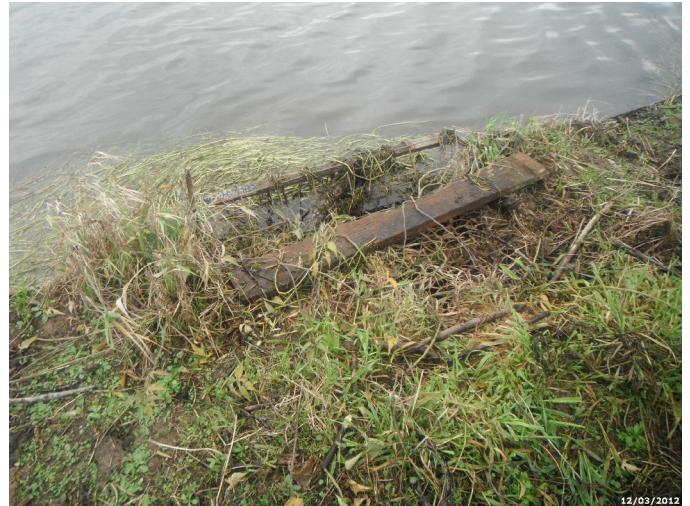
Photo: RIDG\_C4\_4365 Route: 410-001-0.18  
Metal WCS Flashboard Riser 80ft long 24in dia. 3ft deep

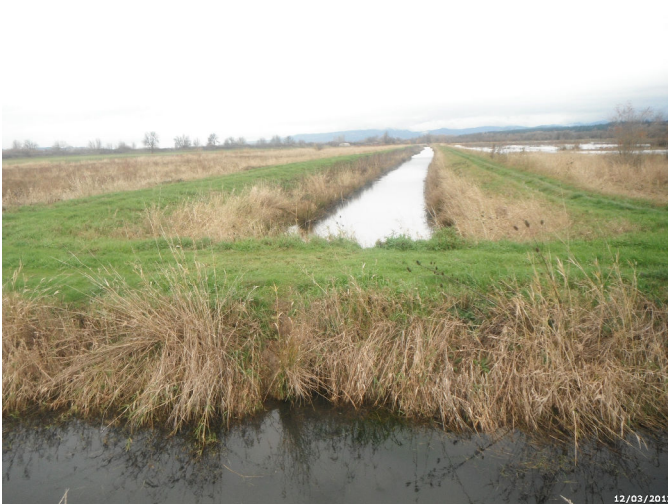
Photo: RIDG\_C4\_4366 Route: 410-001-0.18  
Metal WCS Flashboard Riser 80ft long 24in dia. 3ft deep

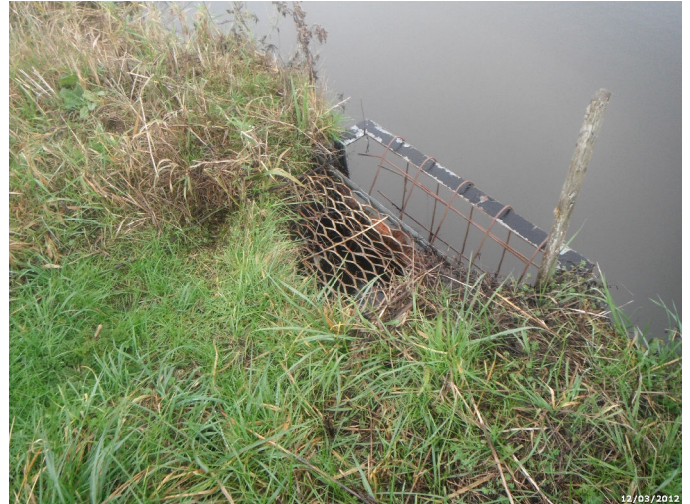
Photo: RIDG\_C4\_4363 Route: 410-001-0.21  
Metal WCS Flashboard Riser 25ft long 24in dia. 1ft deep

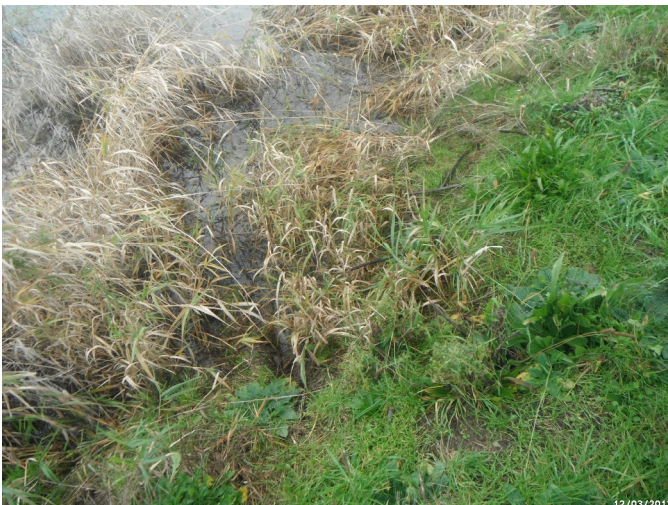
Photo: RIDG\_C4\_4364 Route: 410-001-0.21  
Metal WCS Flashboard Riser 25ft long 24in dia. 1ft deep

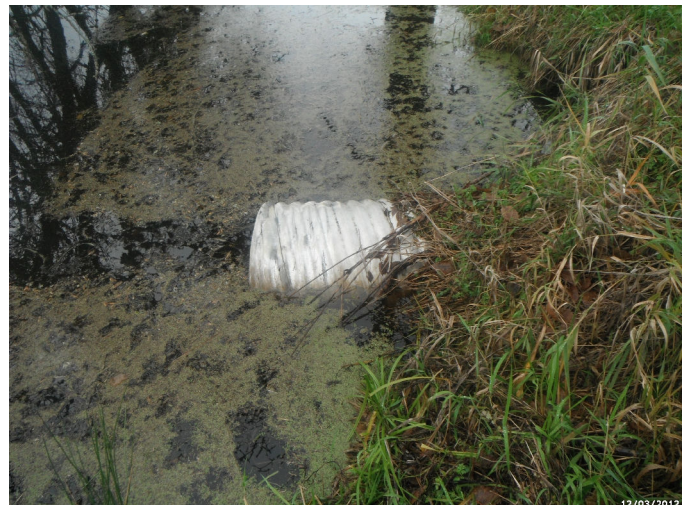
Photo: RIDG\_C4\_4360 Route: 410-001-0.31  
Metal WCS Flashboard Riser 75ft long 24in dia. 1ft deep  
8-024

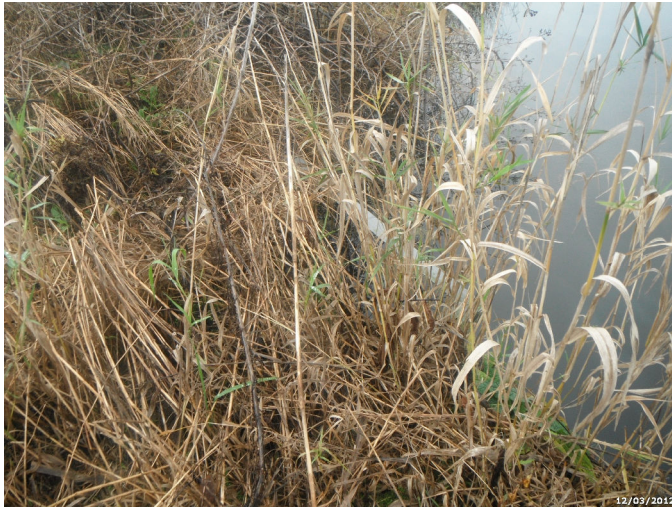
Photo: RIDG\_C4\_4361 Route: 410-001-0.31  
Metal WCS Flashboard Riser 75ft long 24in dia. 1ft deep

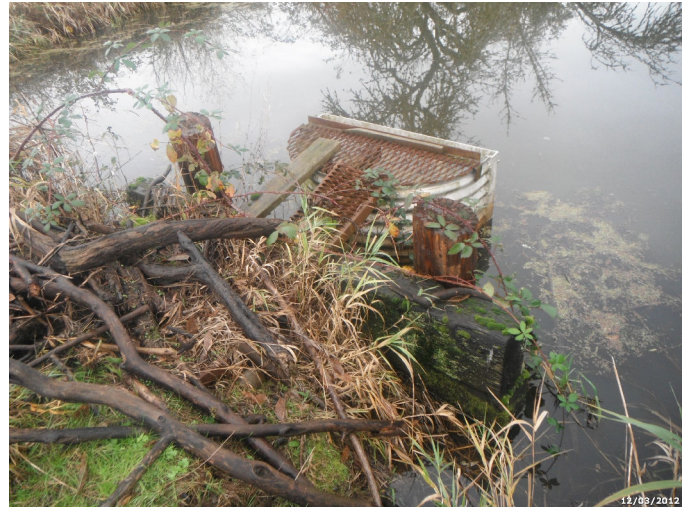
Photo: RIDG\_C4\_4358 Route: 410-001-0.31  
Metal WCS Flashboard Riser 20ft long 24in dia. 1ft deep

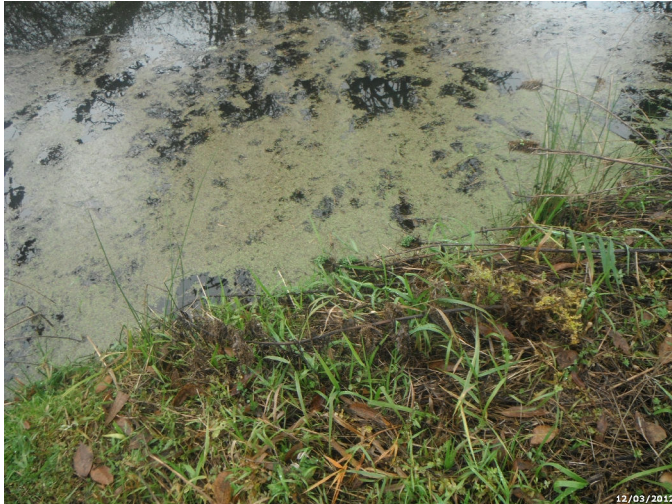
Photo: RIDG\_C4\_4359 Route: 410-001-0.31  
Metal WCS Flashboard Riser 20ft long 24in dia. 1ft deep

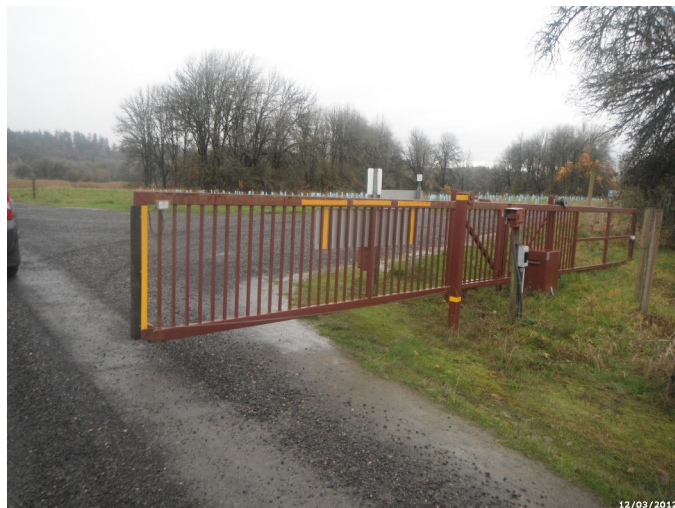
Photo: RIDG\_C4\_4381 Route: 411-001-0.01  
Metal Open Rail Gate Electric

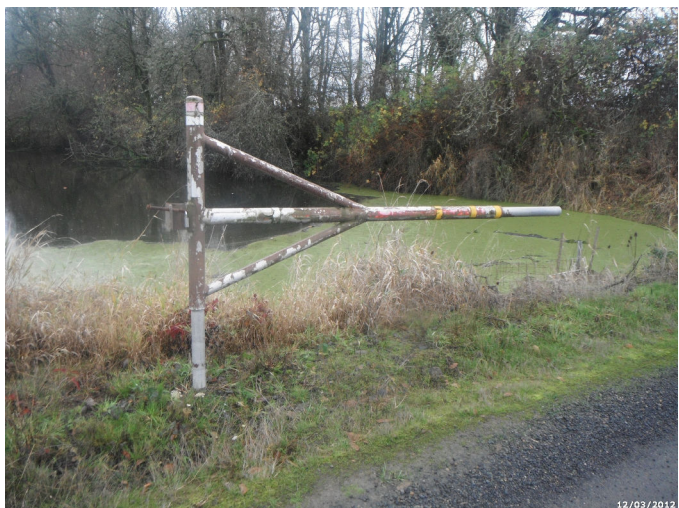
Photo: RIDG\_C4\_4380 Route: 411-001-0.02  
Metal Open Rail Gate

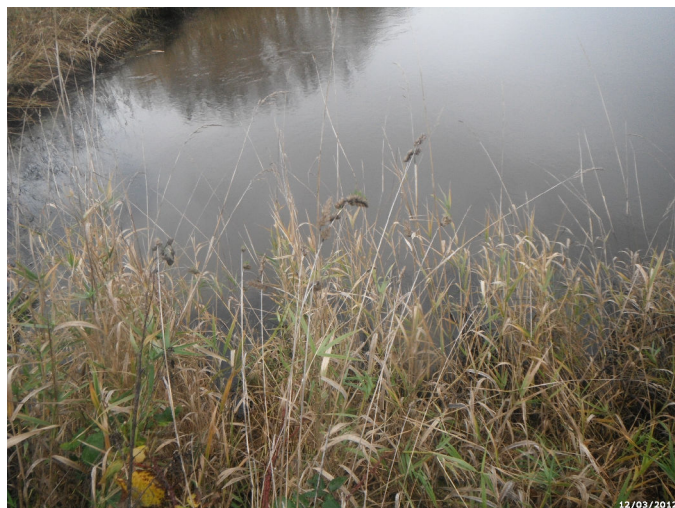
Photo: RIDG\_C4\_4378 Route: 411-001-0.02  
Metal WCS Flashboard Riser 40ft long 24in dia. 5ft deep

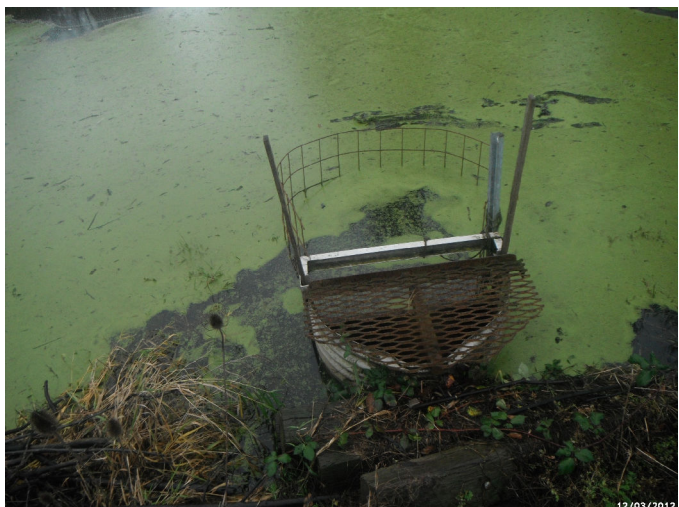
Photo: RIDG\_C4\_4379 Route: 411-001-0.02  
Metal WCS Flashboard Riser 40ft long 24in dia. 5ft deep

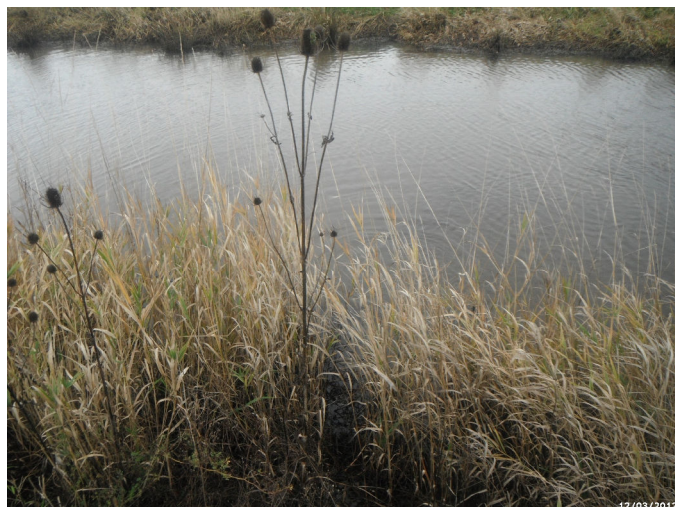
Photo: RIDG\_C4\_4376 Route: 411-001-0.1  
Metal WCS  
Flashboard Riser 40ft long 24in dia. 3ft deep

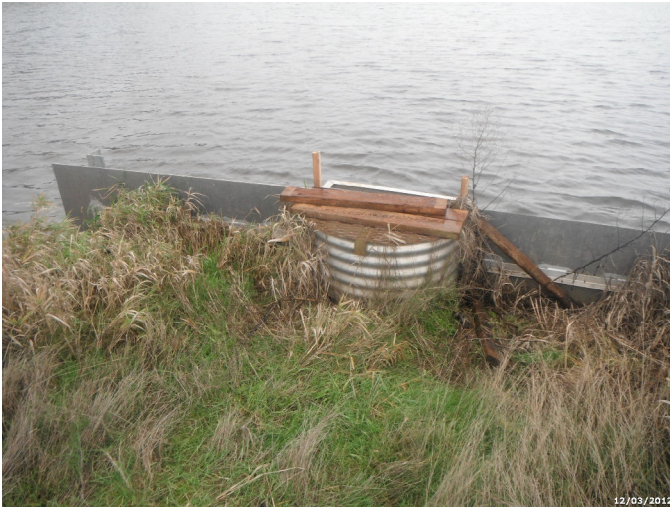
Photo: RIDG\_C4\_4377 Route: 411-001-0.1  
Metal WCS Flashboard Riser 40ft long 24in dia. 3ft deep

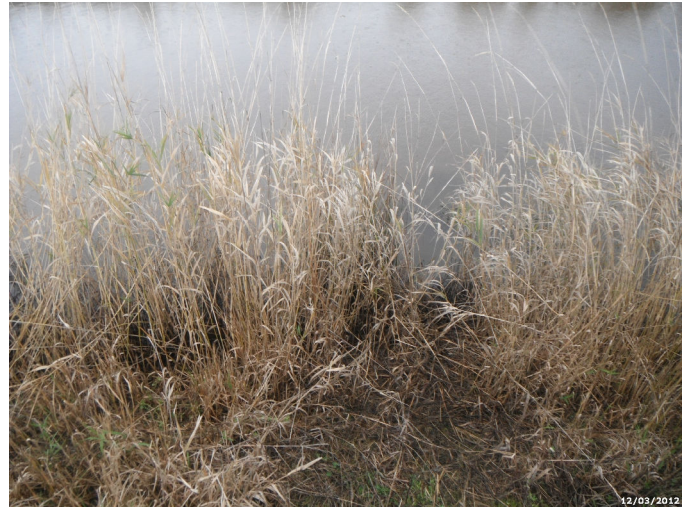
Photo: RIDG\_C4\_4374 Route: 411-001-0.28  
Metal WCS Flashboard Riser 40ft long 24in dia. 4ft deep

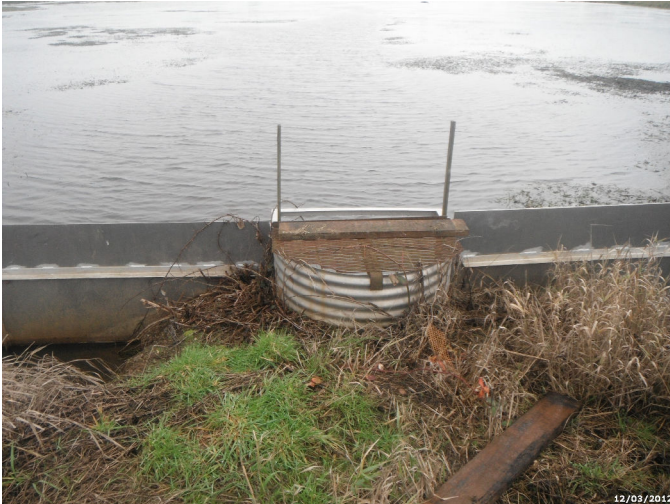
Photo: RIDG\_C4\_4375 Route: 411-001-0.28  
Metal WCS Flashboard Riser 40ft long 24in dia. 4ft deep

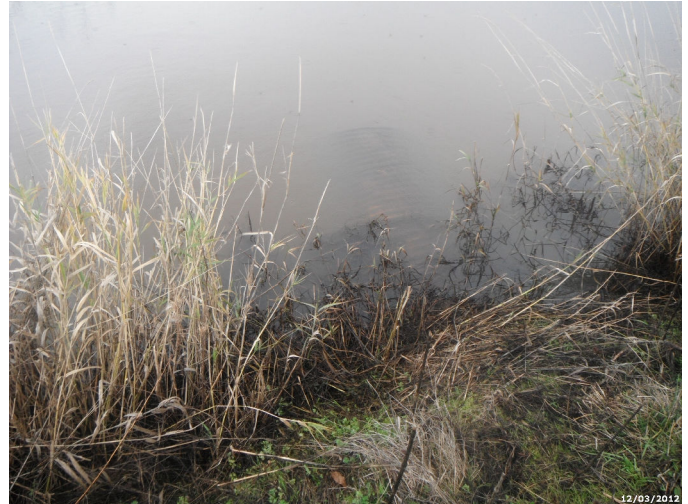
Photo: RIDG\_C4\_4372 Route: 411-001-0.31  
Metal WCS Flashboard Riser 40ft long 48in dia. 4ft deep

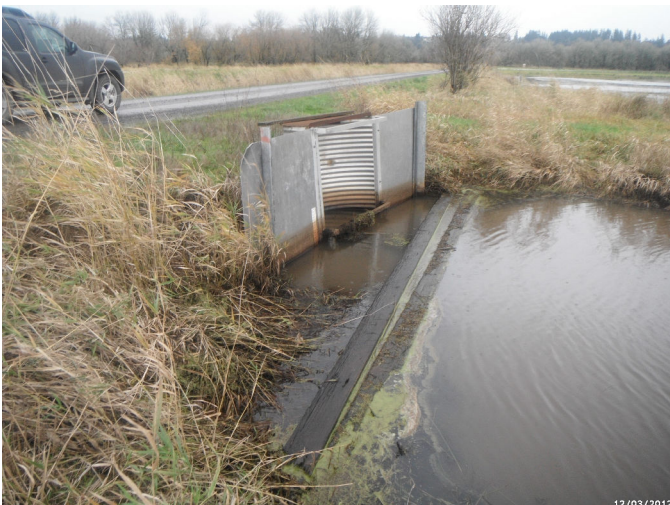
Photo: RIDG\_C4\_4373 Route: 411-001-0.31  
Metal WCS Flashboard Riser 40ft long 48in dia. 4ft deep

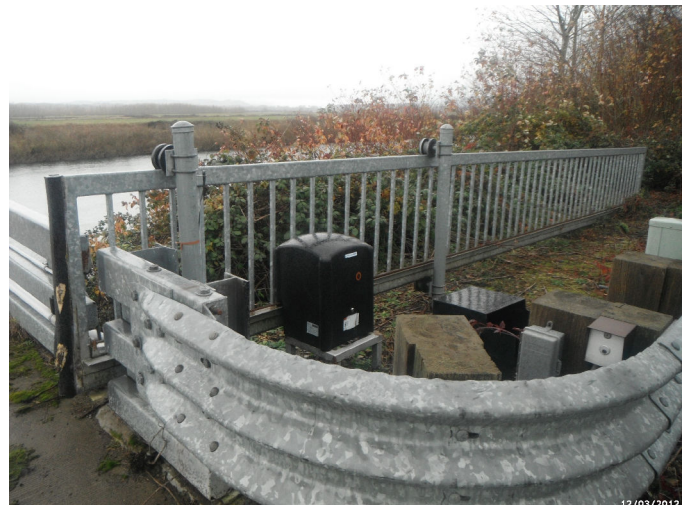
Photo: RIDG\_C4\_4371 Route: 411-001-0.43  
Metal Open Rail Gate Electric

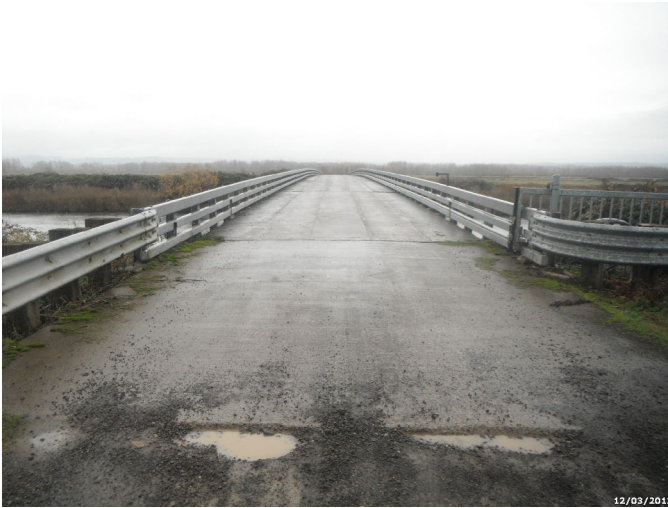
Photo: RIDG\_C4\_4370 Route: 411-001-0.48  
Concrete Bridge NBIS:13551-00092

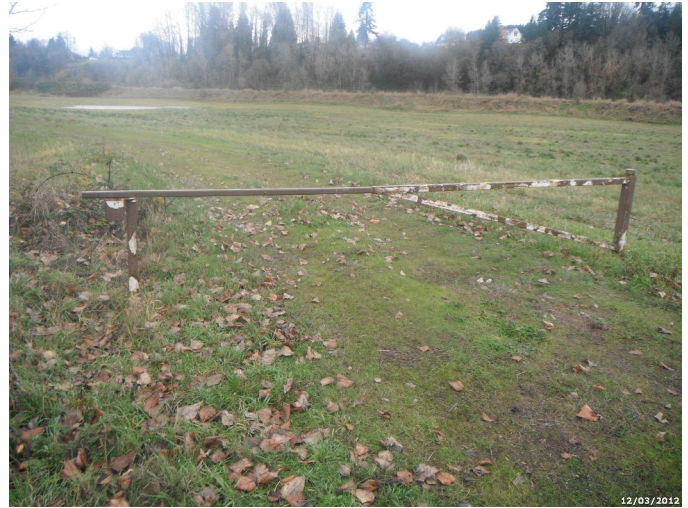
Photo: RIDG\_C4\_4384 Route: 412-001-0.01  
Metal Open Rail Gate

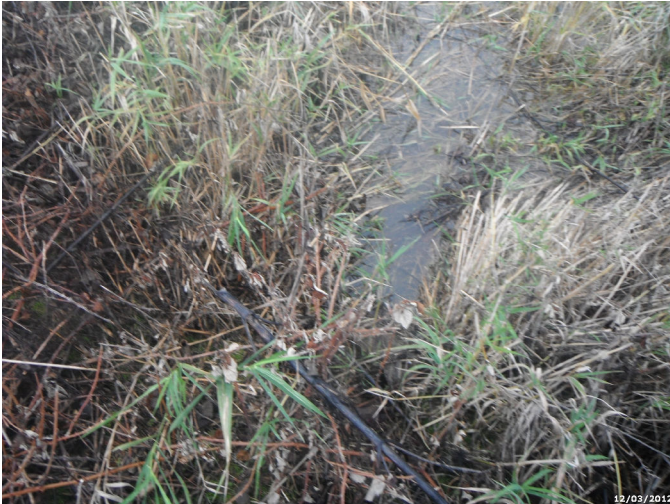
Photo: RIDG\_C4\_4386 Route: 412-001-0.31  
Metal Culvert 25ft long 18in dia. 1ft deep

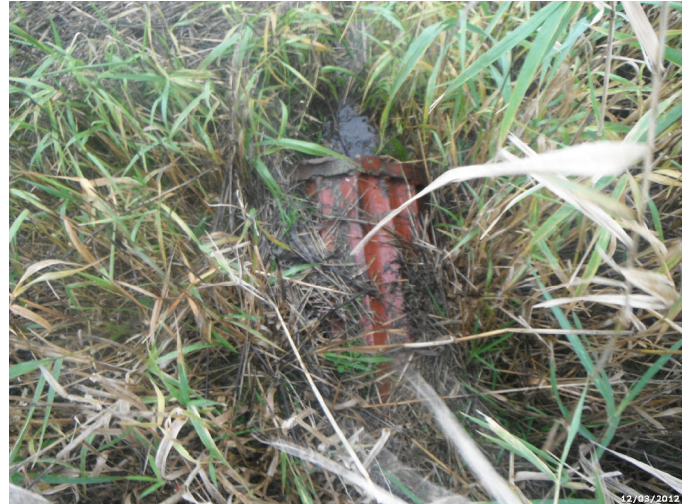
Photo: RIDG\_C4\_4387 Route: 412-001-0.31  
Metal Culvert 25ft long 18in dia. 1ft deep

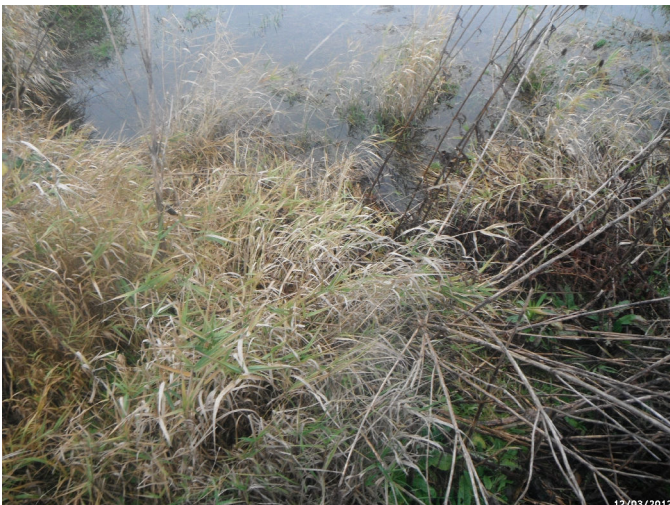
Photo: RIDG\_C4\_4388 Route: 412-001-0.75  
Metal WCS Flashboard Riser 25ft long 24in dia. 3ft deep

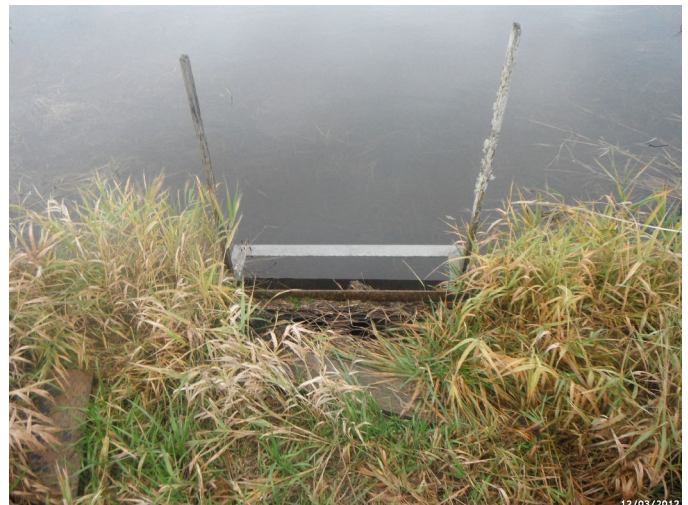
Photo: RIDG\_C4\_4389 Route: 412-001-0.75  
Metal WCS Flashboard Riser 25ft long 24in dia. 3ft deep  
8-029

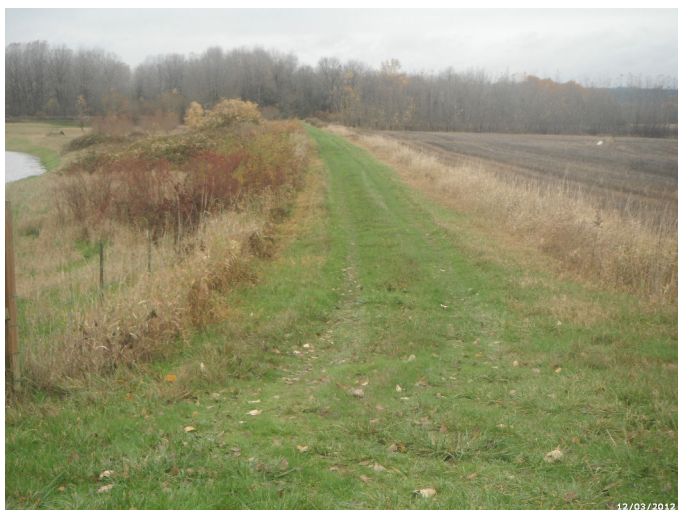
Photo: RIDG\_C4\_4340 Route: 600-001-0.0  
Problem Area BI Outer Dike too wet to drive

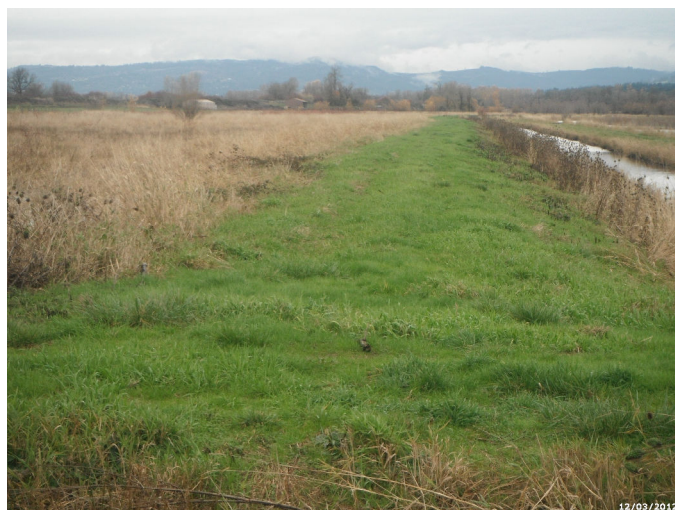
Photo: RIDG\_C4\_4367 Route: 600-001-0.0  
Problem Area West Drain Road too wet to drive
